***MATERIEX CASE STUDY***  
**LEAKAGE IN SEAWATER COOLING SYSTEM**

Shortly after the commissioning of an offshore HVDC converter station in the North Sea, leakage was discovered in the seawater cooling system. The cooling system consisted of pipes and flanges that had been joined by welding. According to materials certificates, the pipes, flanges, and welds should meet the criteria for super duplex stainless steel conforming with EN 1.4410.

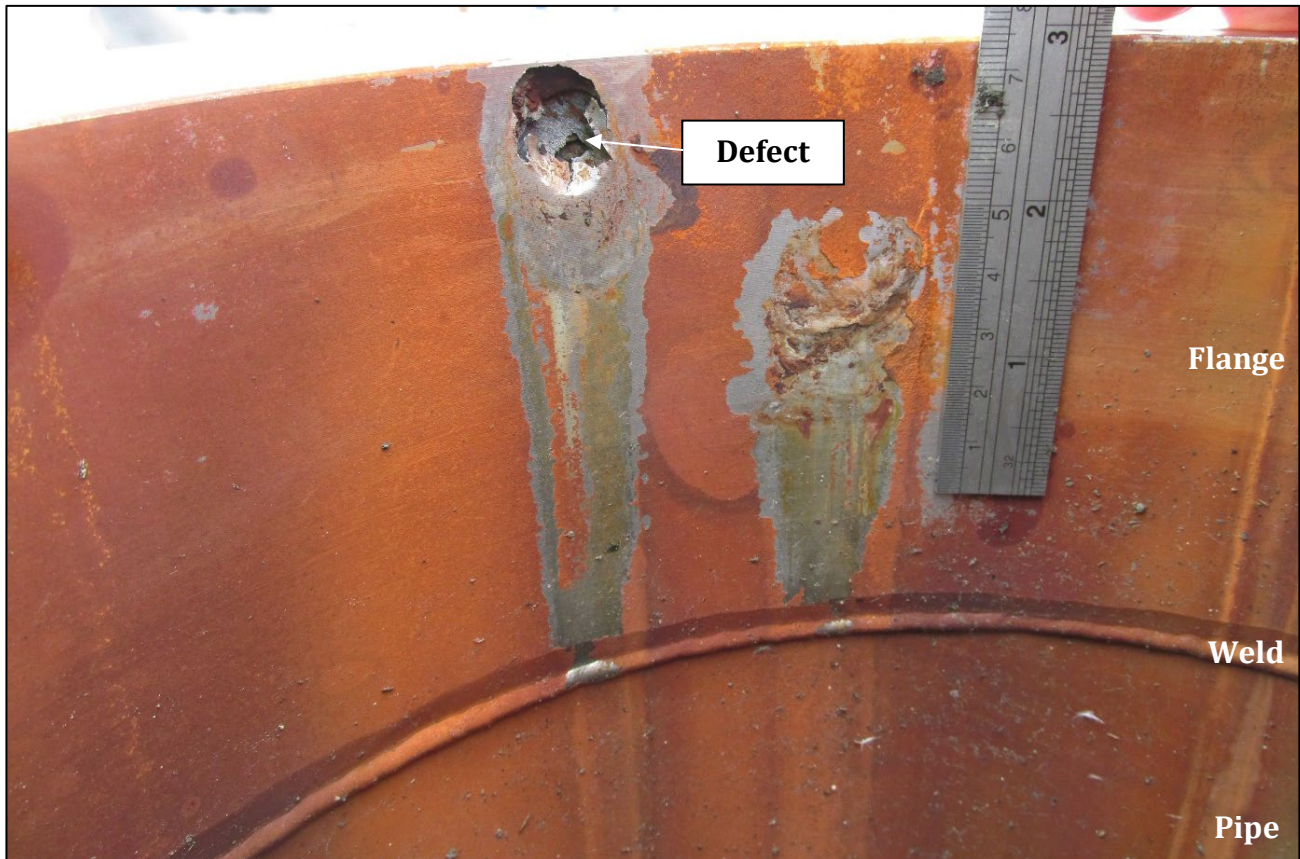
- Cracks and defects (Figure 1) were observed in several flanges whereas the pipes and welds appeared to be in a good condition.
- A detailed study using SEM showed that the cracked flange had the character of a typical brittle cleavage mode of fracture (Figure 2).

**Figure 1.** Flange defect observed during on-site inspection.

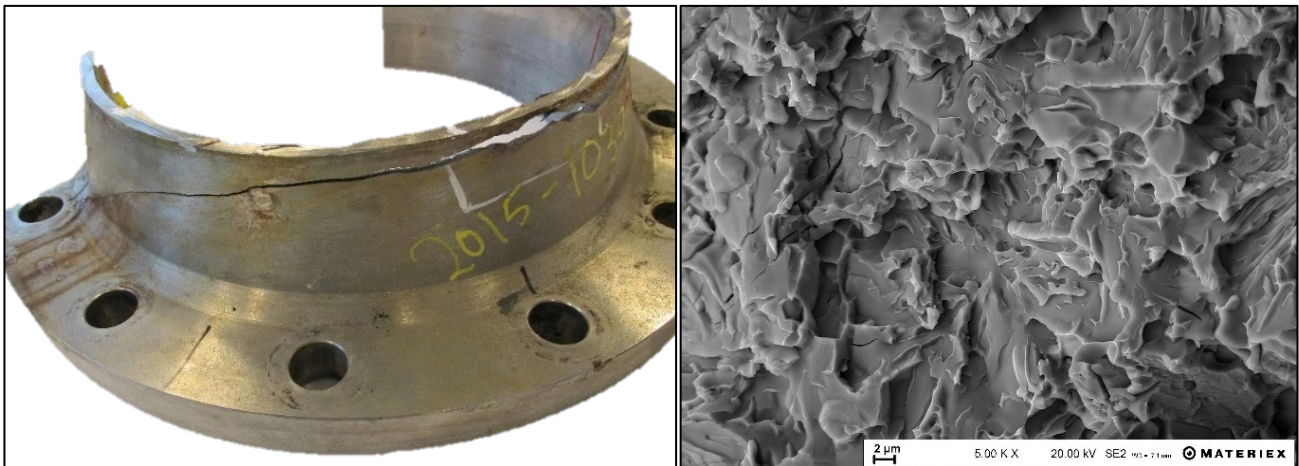
The flange material had suffered from what in the literature is known as Sigma phase embrittlement that had dramatically reduced the corrosion resistance and ductility of the flange material. Exposure to seawater had subsequently accelerated local corrosion and promoted cracking. Sigma phase is an undesired chromium/molybdenum-rich intermetallic phase that can form during incorrect heat treatment of stainless steel. Most likely, too slow cooling through the 700-900 °C temperature range has led to the eutectoid transformation of ferrite into sigma phase and secondary austenite.

**Figure 2.** Left: cracked flange. Right: SEM-image of fracture surface showing a brittle cleavage mode of fracture.

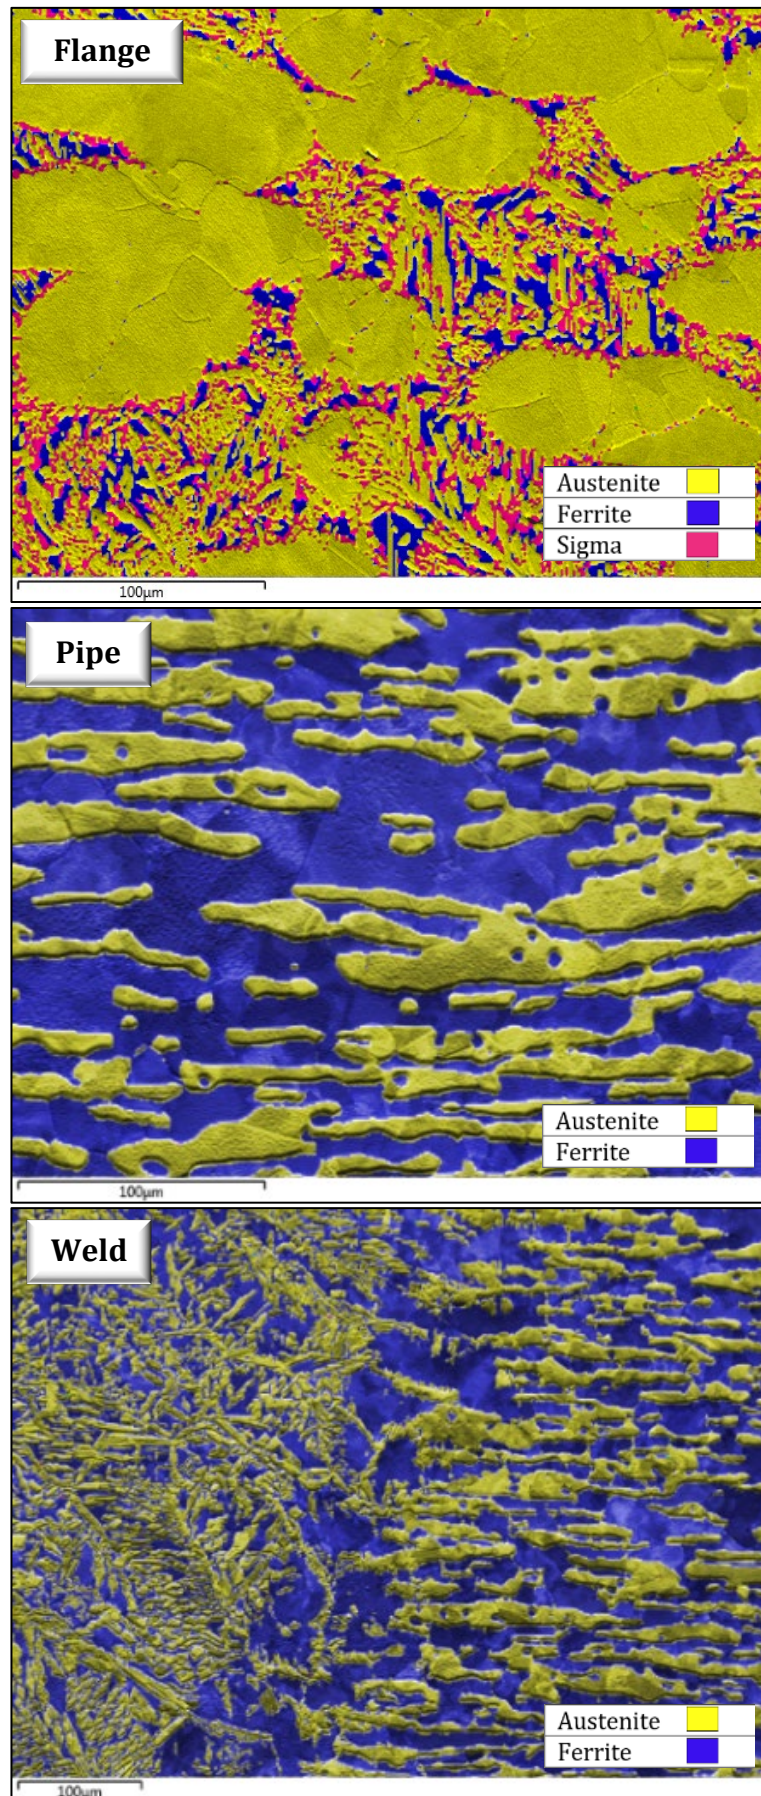
- EBSD phase mapping of the microstructure unambiguously confirmed the presence of sigma phase in all investigated flange samples (Figure 3a) whereas the pipes and welds had an expected microstructure free from sigma phase and with a homogenous distribution of ferrite and austenite (Figure 3b-c).

- The hardness was higher than specified in areas rich in sigma phase (>10 wt.-%), as shown in Table 1. However, the pipe hardness was lower and did meet requirements according to the materials specifications.

**Figure 3.** EBSD phase mapping revealing the presence of Sigma phase in flange material. The pipes and welds were free from sigma phase and had an expected microstructure of austenite and ferrite.
