MATERIEX CASE STUDY

M8 SCREW FRACTURE

A fractured M8x40 hexagon socket set screw was received for failure investigation. According to the given information, the fracture was observed some time after the screw had been tightened. The screw material was specified to conform with zinc electroplated steel with the property class 45H (minimum hardness 450 HV). *This is only a shortened version/summary of the original report.*

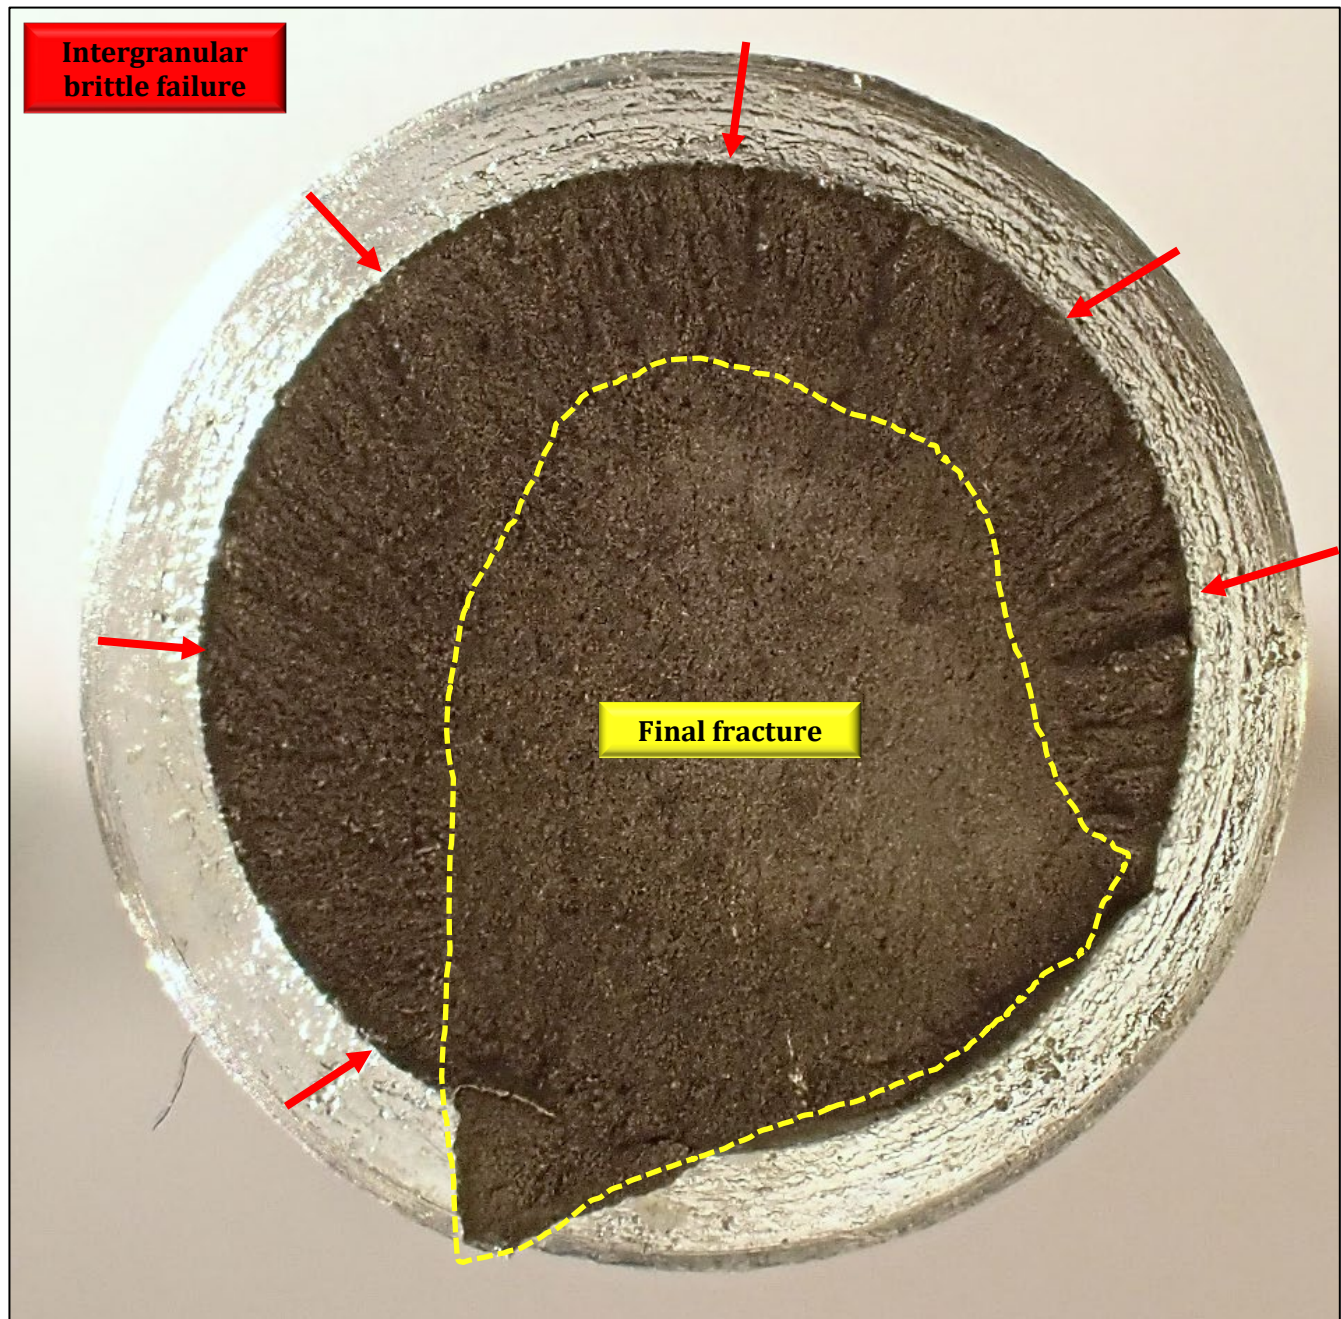
- The hardness was measured to ~505 HV which met the criteria for property class 45H.
- The macroscopic appearance of the fracture suggests that the fracture has been initiated in the thread root, along the circumference (indicated by red arrows in Figure 1) and rapidly propagated inwards/downwards towards the final fracture (yellow marked area in Figure 1).

Figure 1. Fracture surface, red arrows indicate crack initiation sites with an intergranular brittle mode of fracture. The yellow marked area shows the final fracture.

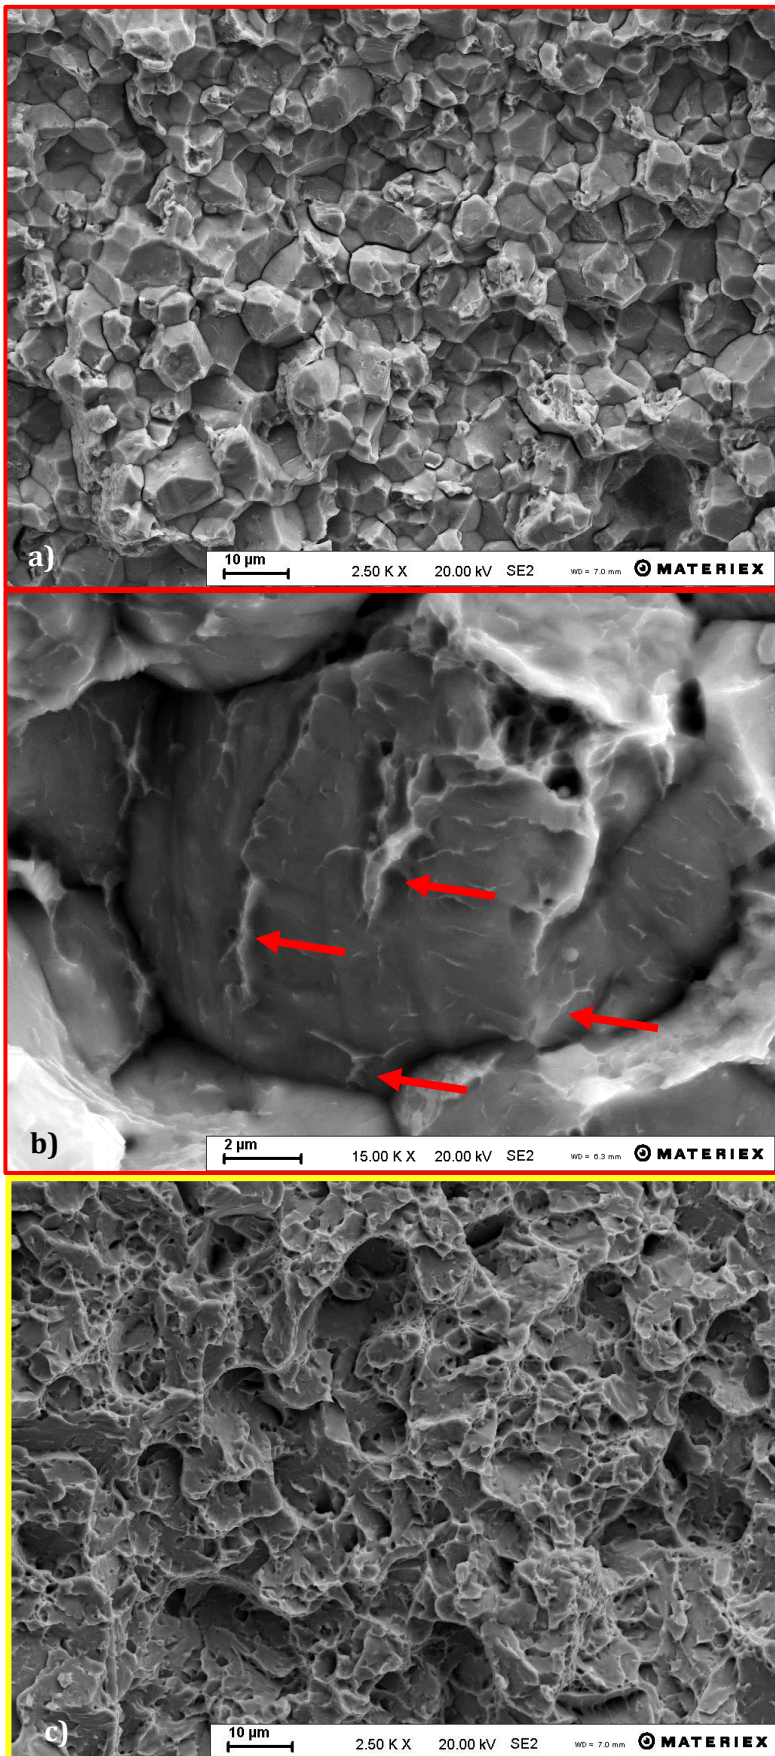
- Investigation in SEM confirmed that the fracture had been initiated in the thread root. The fracture surface in this area had an intergranular brittle mode of fracture along the prior austenite grain boundaries (Figure 2a). The grain facets exhibited so-called “crow’s feet” (Figure 2b) which is a microscopic feature typically associated with hydrogen embrittlement. The intergranular fracture covered approximately 30-40 % of the total area fraction whereas the rest of the fracture surface (the final fractures) had a mixed ductile and brittle cleavage mode of fracture (Figure 2c).

Multiple factors strongly indicate that the fracture is caused by hydrogen embrittlement;

1. The character of the fracture surface; intergranular and with the presence of so-called “crow’s feet”.
2. Material properties; The screw is made of high strength steel with a hardness of ~505 HV. High strength materials (>~1000 MPa yield stress) are more susceptible to hydrogen embrittlement.
3. The timing of the fracture; the fracture did not occur immediately upon tightening but after some time.
4. The location of the fracture; The fracture was initiated in an area where high stresses are expected (e.g. thread roots).
5. Manufacturing process; The screw was zinc coated by electroplating which is known to be a process where hydrogen can enter and get trapped in the material.

**Figure 2. a) Intergranular brittle mode of fracture revealing austenite grain boundaries.
 b) High magnification image of a), showing the so-called crow's feet (red arrows).
 c) Final fracture showing a mixed ductile and brittle cleavage mode of fracture.**
