HYDROGEN EMBRITTLEMENT IN STEEL FASTENER

A fractured M8x40 hexagon socket set screw was received for failure investigation. According to the given information, the fracture was observed some time after the screw had been tightened. The screw material was specified to conform with zinc electroplated steel with the property class 45H (minimum hardness 450 HV).

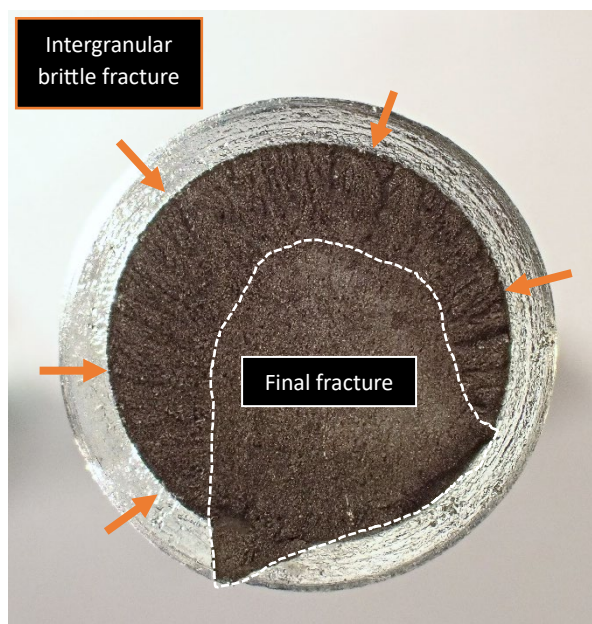
- The hardness was measured to ~505 HV which met the criteria for property class 45H.
- The macroscopic appearance of the fracture suggests that the fracture has been initiated in the thread root along the circumference (arrows in Figure 1) and rapidly propagated inwards/downwards towards the final fracture (white marked area in Figure 1).
- Investigation in SEM confirmed that the fracture had been initiated in the thread root. The fracture surface in this area had an intergranular brittle mode of fracture along the prior austenite grain boundaries (Figure 2). The grain facets exhibited so-called “crow’s feet” (Figure 3) which is a microscopic feature typically associated with hydrogen embrittlement. The final fracture had a mixed ductile and brittle cleavage mode of fracture.

Figure 1. Fracture surface, arrows indicate crack initiation sites with an intergranular brittle mode of fracture. The white marked area shows the final fracture.

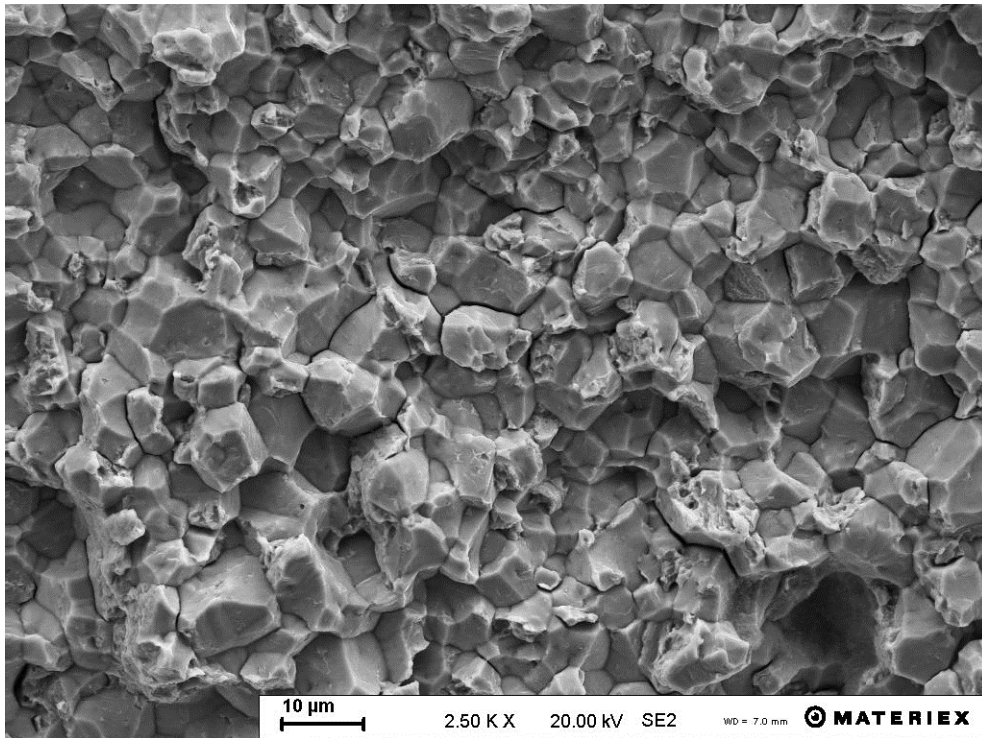
Figure 2. Intergranular brittle mode of fracture revealing austenite grain boundaries.

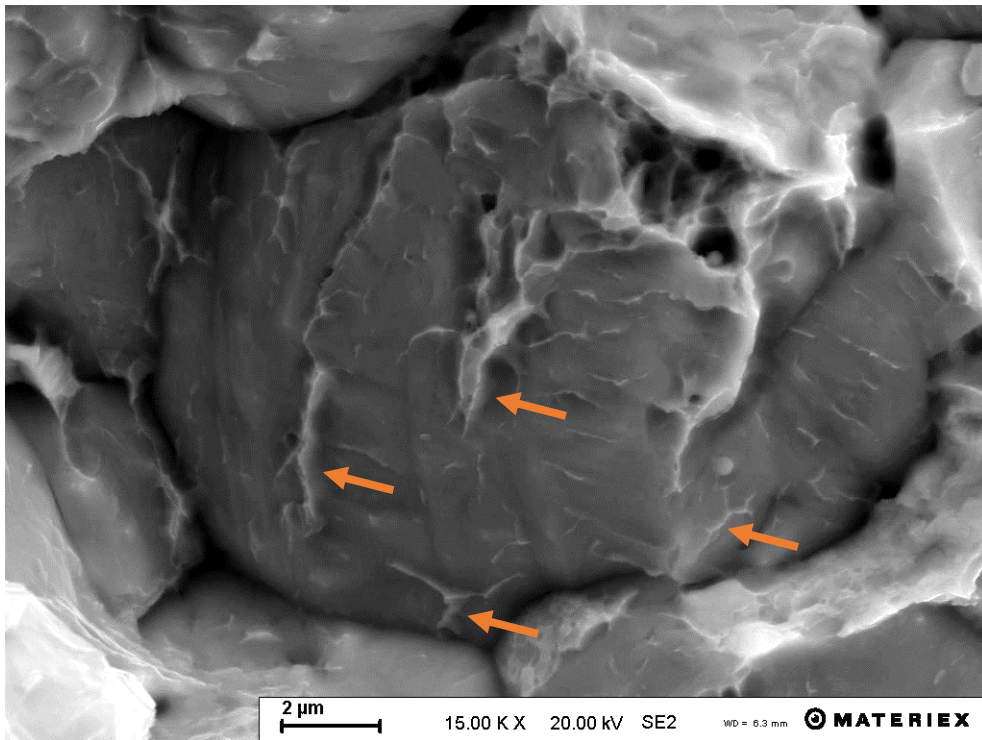
Figure 3. High magnification SEM- image showing the so-called crow's feet.
