HYDROGEN EMBRITTLEMENT IN STEEL FASTENER

BACKGROUND

A fractured M8x40 hexagon socket set screw was received for failure investigation. According to the given information, the fracture was observed some time after the screw had been tightened. The screw material was specified to conform with zinc electroplated steel with the property class 45H (minimum hardness 450 HV).

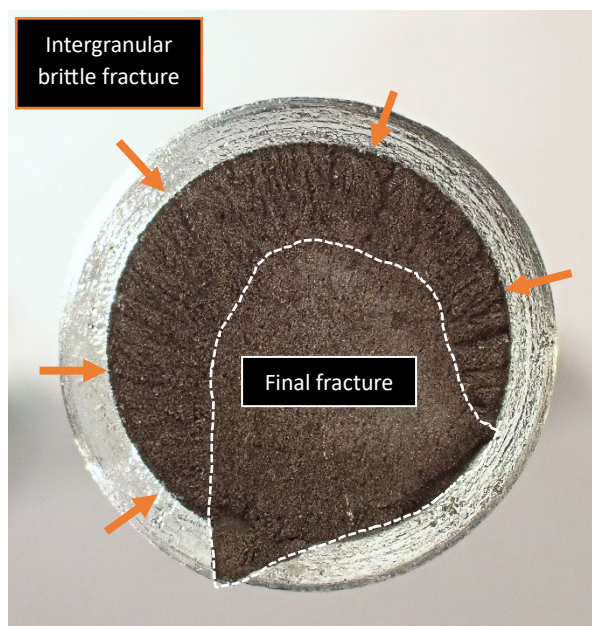
- The hardness was measured to 505 HV which meet the criteria for property class 45H.
- The macroscopic appearance of the fracture suggests that the fracture had been initiated in the thread root along the circumference (arrows in Figure 1) and rapidly propagated inwards/downwards towards the final fracture (white marked area in Figure 1).
- Investigation in SEM confirmed that the fracture had been initiated in the thread root. The fracture surface in this area had an intergranular brittle mode of fracture along the prior austenite grain boundaries (Figure 2). The grain facets exhibited so-called “crow’s feet” (Figure 3) which is a microscopic feature typically associated with hydrogen embrittlement. The final fracture had a mixed ductile and brittle cleavage mode of fracture.

Figure 1. Fracture surface, arrows indicate crack initiation sites with an intergranular brittle mode of fracture. The white marked area shows the final fracture.

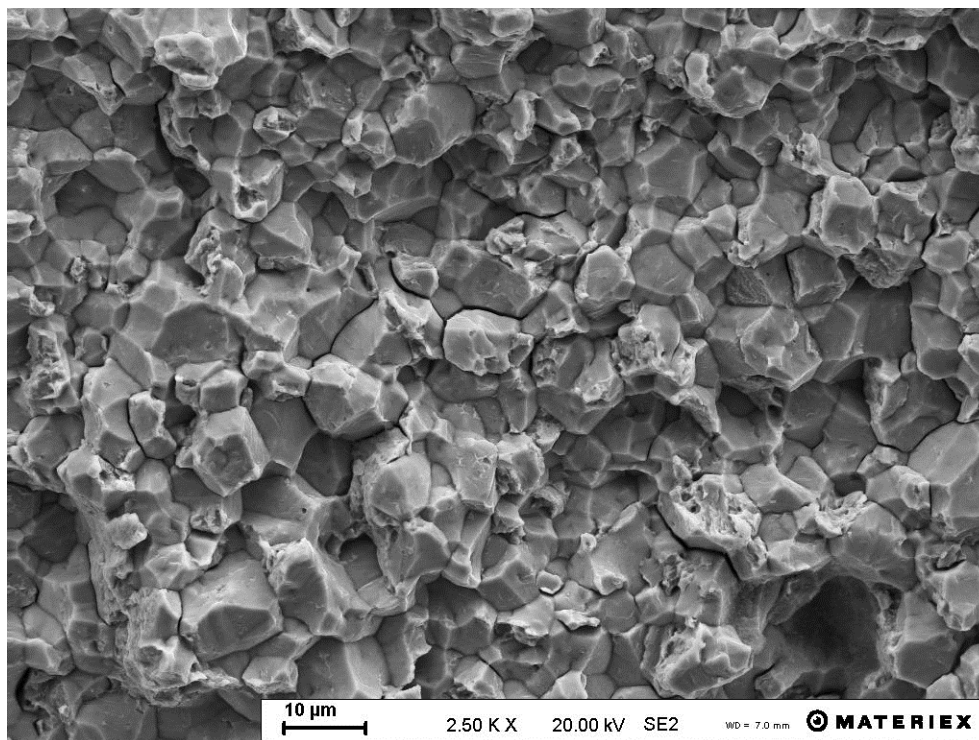
1. The character of the fracture surface: intergranular and with the presence of so-called “crow’s feet”.
2. Material properties: the screw is made of high strength steel with a hardness of 505 HV. High strength materials (>1000 MPa yield stress) are more susceptible to hydrogen embrittlement.
3. The timing of the fracture: the fracture did not occur immediately upon tightening but after some time.
4. The location of the fracture: the fracture was initiated in an area where high stresses are expected (e.g. thread roots).
5. Manufacturing process: the screw was zinc coated by electroplating which is known to be a process where hydrogen can enter and get trapped in the material.

Figure 2. Intergranular brittle mode of fracture revealing austenite grain boundaries.

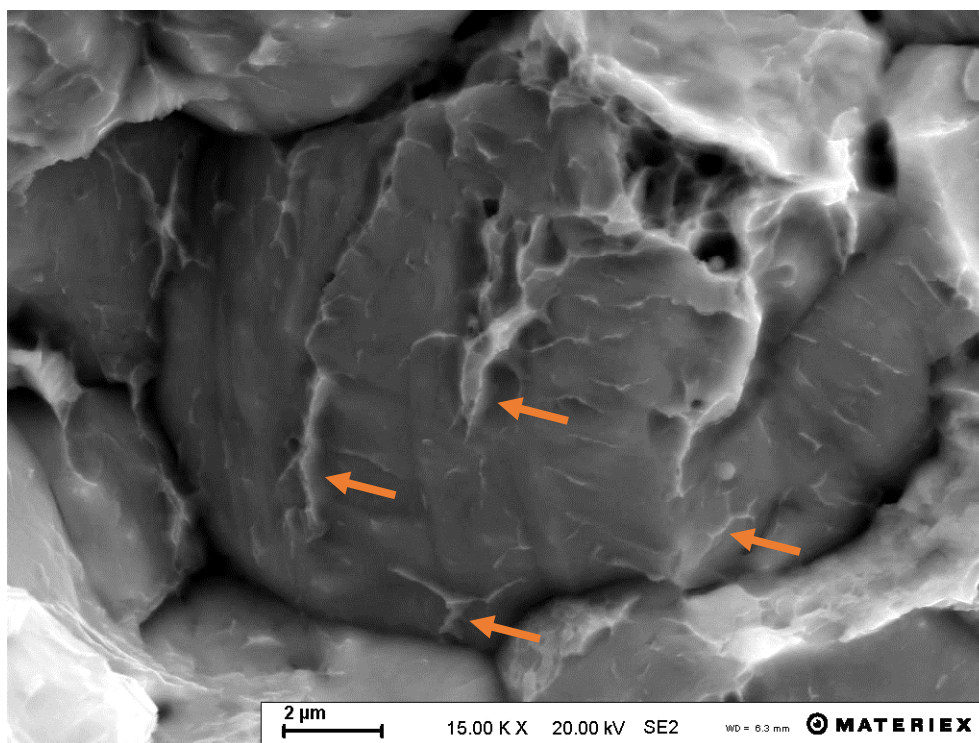
Figure 3. High magnification SEM- image showing the so-called crow's feet.
