LEAKAGE IN RADIATOR FITTINGS

Dezincification and stress corrosion cracking

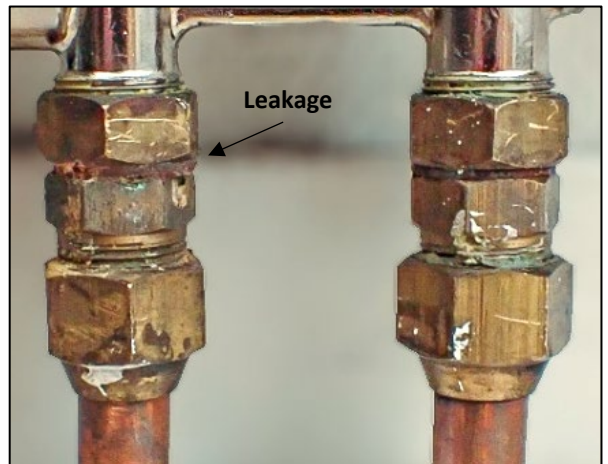
About 3 months after the replacement of a thermostatic radiator valve, a leakage suddenly occurred in one of the two fittings between the thermostat and the connected water pipes (Figure 1). During the valve replacement, the fittings had been loosened but not removed, and then reused. As there was no information of previous work done on the radiators, the fittings were assumed to be from the end of the 1960s, when the house was built.

Figure 1. Leaking vs non leaking fitting.

The leakage could probably have been prevented if fittings in dezincification-resistant brass had been installed during the thermostat change, instead of reusing the old fittings that were made of an alloy that is generally not resistant to corrosive mediums that might be used in the specific environment. Brass is particularly sensitive to ammonia, which is commonly found in some all-purpose cleaning agents.

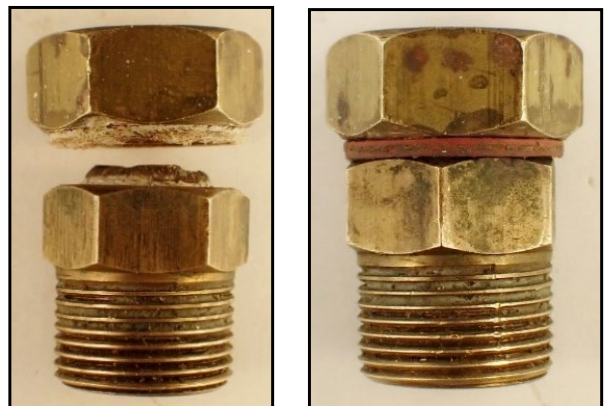
- The leakage had occurred due to cracking initiated at the sharp corner on the outer surface of the fitting (Figure 2).
- Investigation in SEM showed that the area adjacent to the fracture surface had suffered from dezincification (Figure 3). The same area in the non-leaking fitting had also suffered from dezincification and smaller cracks (100 µm) were observed (Figure 4). Dezincification is a corrosion process that selectively removes zinc from the brass alloy (if Zn>15%), leaving a porous copper-rich structure with reduced mechanical strength.
- The chemical composition of the fittings was identified as brass CW608N (60% Cu, 38% Zn, 2% Pb).
- The mode of fracture at the crack initiation sites was identified as ductile (Figure 5a). However, the majority of the fracture surface had an intergranular brittle mode of fracture (Figure 5b).

Figure 2. Leaking (fractured) fitting vs non-leaking fitting.

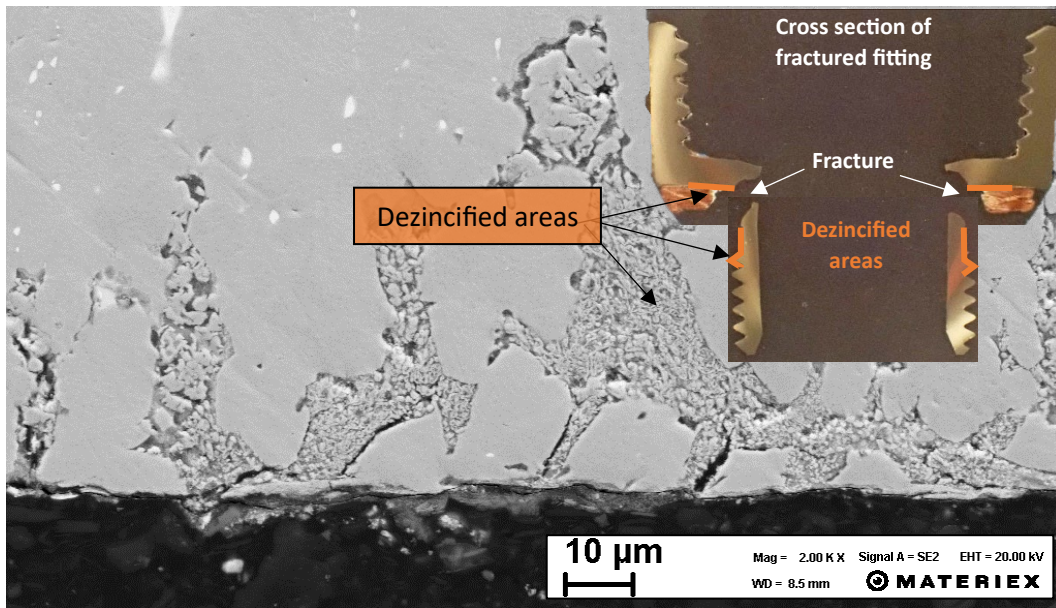
The fracture had been initiated by brass dezincification resulting in a reduced mechanical strength. As a consequence, the torque used during re-tightening after the thermostat change has probably been sufficient for the crack initiation to occur. However, the fact that the majority of the fracture surface had an intergranular brittle mode of fracture suggests that Stress corrosion cracking (SCC) may have been triggered by the induced stresses caused by the dezincification and the initial stages of cracking.

Figure 3. SEM-image of dezincified surface adjacent to the crack initiation sites (fractured area).

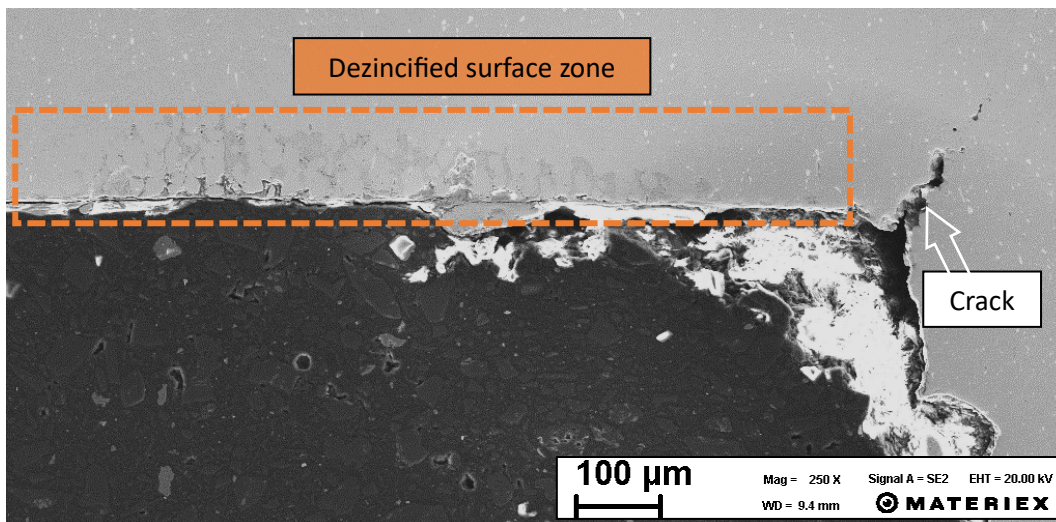
Figure 4. Non-leaking fitting shows dezincified surface and cracking in the same area as the fractured fitting.

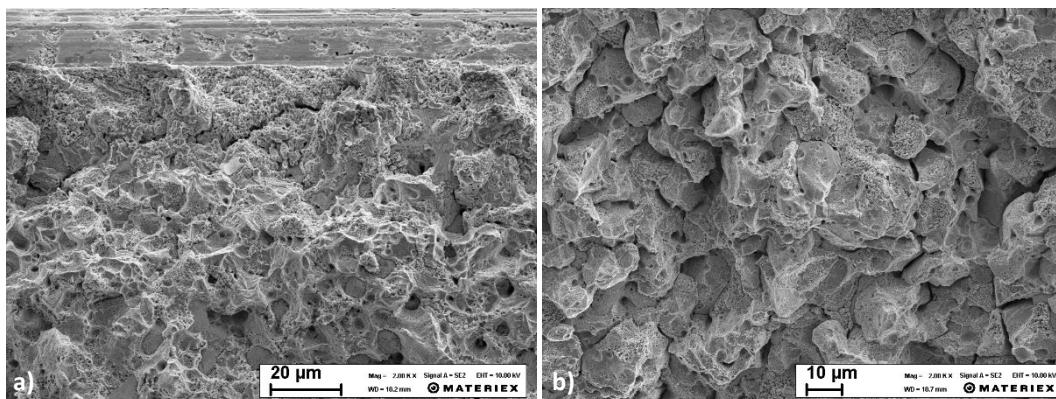
Figure 5. SEM-images of fracture surface showing a) a ductile mode of fracture at crack initiation site, b) Intergranular brittle mode of fracture at the majority of the fracture surface.
