LEAKING SEAWATER SYSTEM

Sigma phase embrittlement in pipe flanges

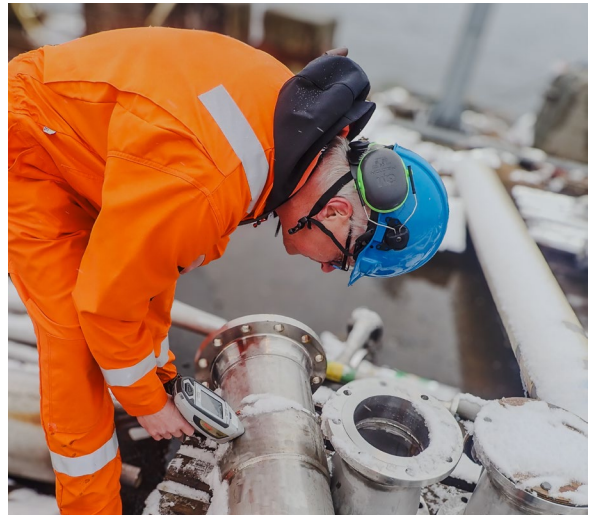
Figure 1. Chemical characterisation of pipe system on-site.

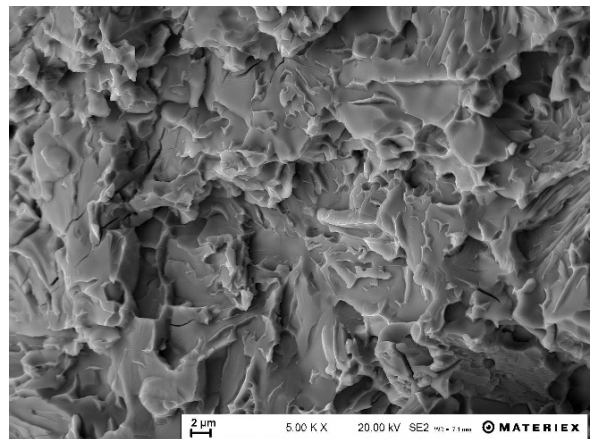
- Cracks and defects were observed in several flanges whereas the pipes and welds appeared to be in good condition.
- A detailed study using SEM showed that the cracked flange had the character of a typical brittle cleavage mode of fracture (Figure 2).
- EBSD phase mapping of the microstructure confirmed the presence of sigma phase in all investigated flange samples (Figure 3a). However, the pipes had an expected microstructure free from sigma phase and with a homogenous distribution of ferrite and austenite (Figure 3b).
- The hardness was higher than specified in areas rich in sigma phase (>10 wt.-%), as shown in Table 1. The pipe hardness was lower and did not meet requirements according to the materials specifications.
- The chemical composition of all analysed pipes and flanges conformed with the specified super duplex stainless steel.

Figure 2. Brittle cleavage mode of fracture, fractured flange.

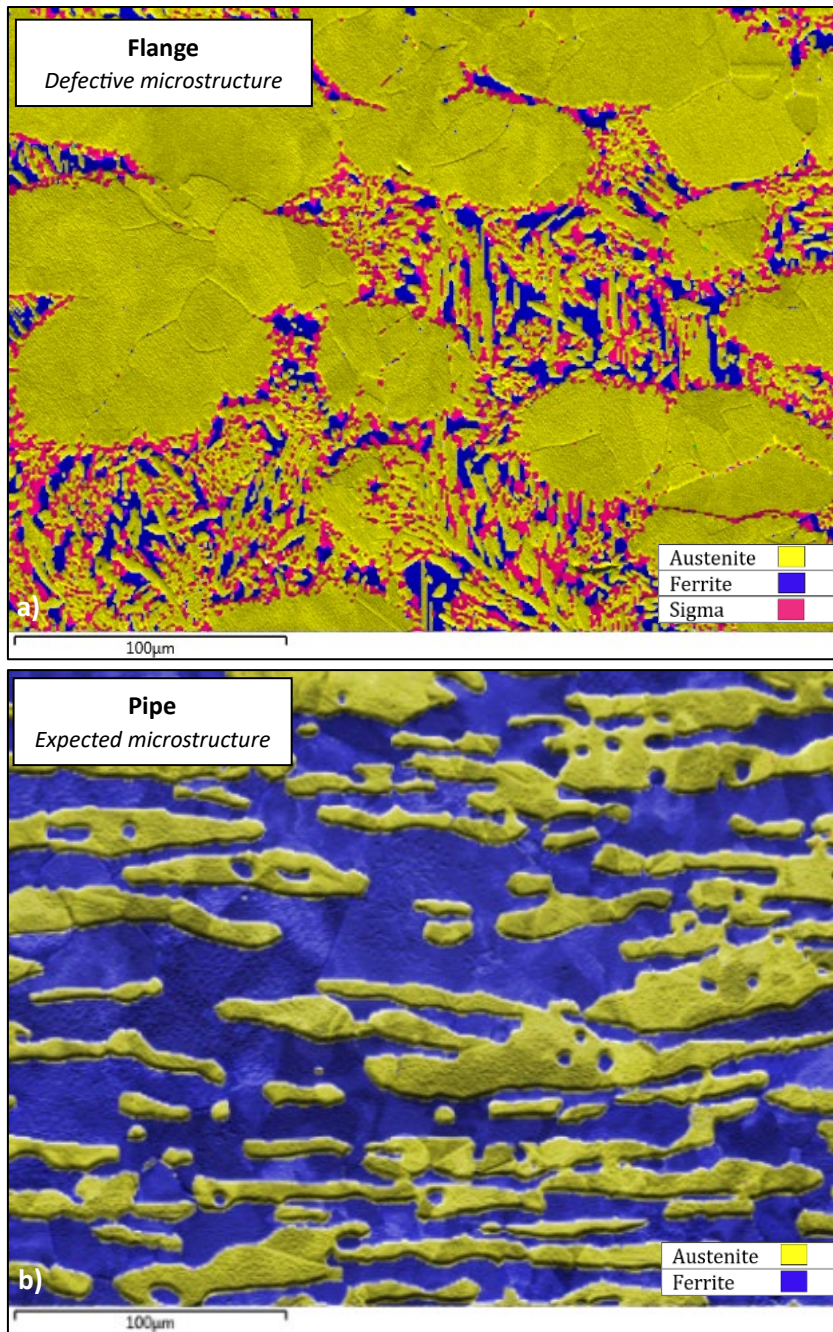
The flange material had suffered from what in the literature is known as Sigma phase embrittlement that had dramatically reduced the corrosion resistance and ductility of the flange material. Exposure to seawater had subsequently accelerated local corrosion and promoted cracking. Sigma phase is an undesired chromium/molybdenum-rich intermetallic phase that can form during incorrect heat treatment of stainless steel. Most likely, too slow cooling through the 700-900 °C temperature range after heat treatment has led to the eutectoid transformation of ferrite into sigma phase and secondary austenite.

Figure 3. EBSD- phase mapping showing a) a defective microstructure with the presence of sigma phase, b) expected microstructure with a homogenous distribution of austenite and ferrite.
