STEAM TURBINE FAILURE

Fatigue induced blade ruptures

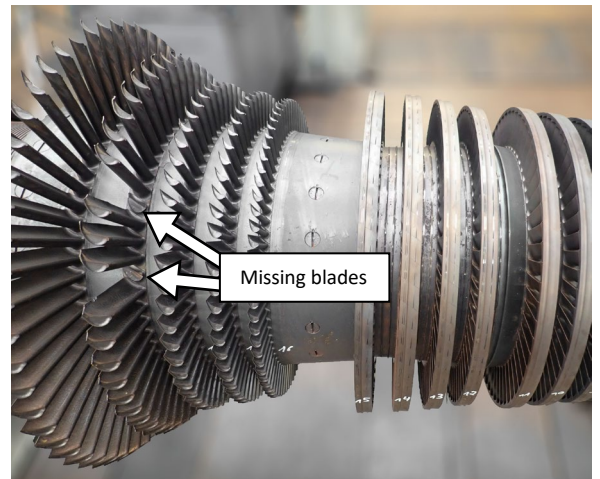
Two low pressure (LP) steam turbine rotor blade ruptures were discovered during an inspection that was carried out due to high vibrations during start-ups. The two ruptured blades had both been mounted in row 19, the 1st row in the LP stage. The blade material was specified to conform with EN 1.4923.

Figure 1. Two missing blades in LP-stage of steam turbine.

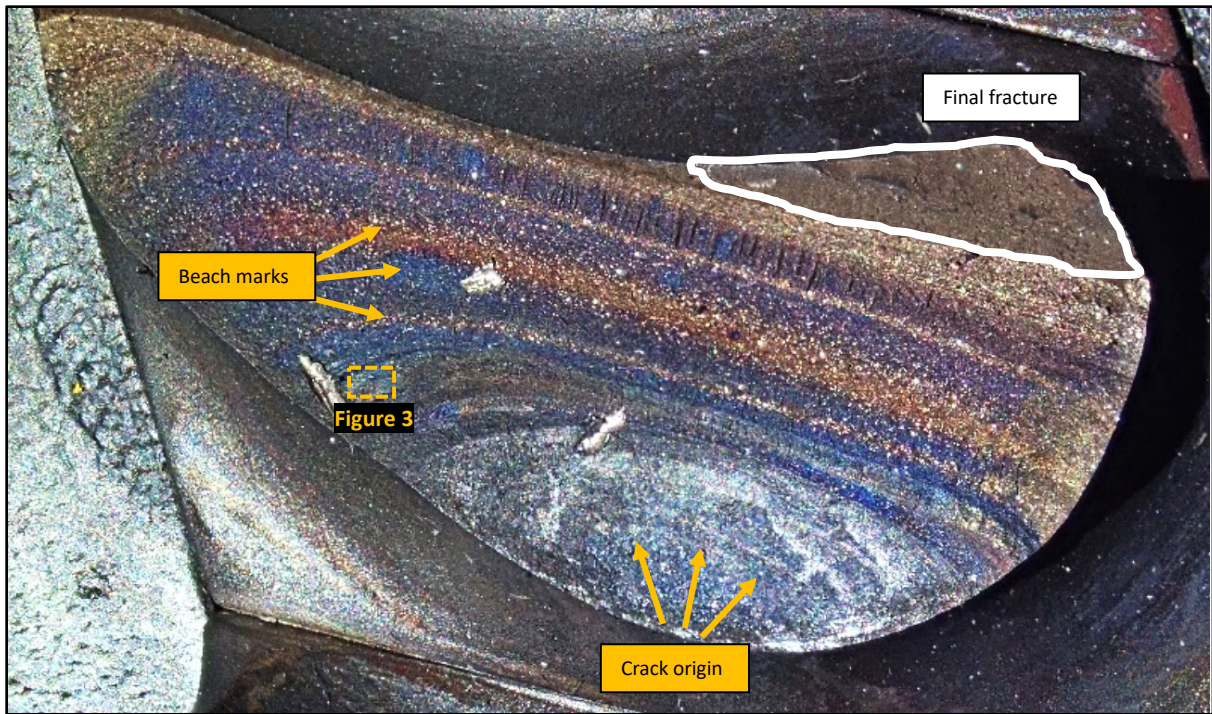
- Chemical composition and hardness measurements showed that the rotor blade material conformed with the specifications (Table 1-Table 2).
- The macroscopic appearance with beach marks visible on the fracture surfaces (Figure 2) indicated that the blade fractures had been caused by fatigue, initiated at the suction side of the blade roots. Beach marks are macroscopic concentric rings that represent sudden changes in load and/or environmental conditions.

- The total number of beach marks was estimated to be 30-50 which may be interpreted to equal the number of starts/stops needed to cause the fracture. The different colours of the beach marks indicate various degrees of oxidation which can be referred to different stages under which the fatigue crack has propagated.

Figure 2. Fracture surface of the blade root, shows a large number of beach marks indicating that the fracture has been caused by fatigue.

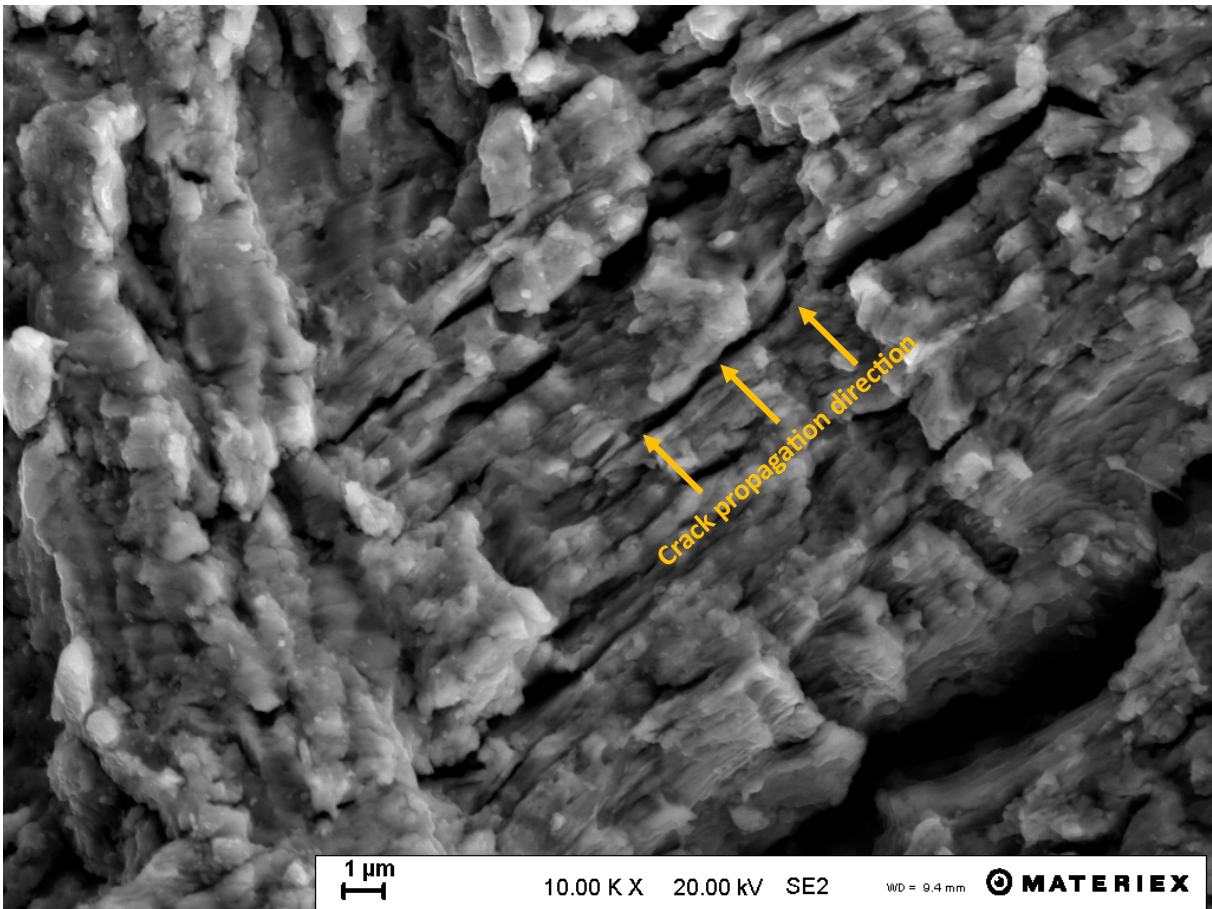
- A detailed study of the fracture surface in SEM showed the presence of so-called striations (Figure 3). Striations are microscopic parallel lines associated with fatigue failures where each line represents the crack front during one load cycle. The shape of the striations further confirmed that the fractures had been initiated at the suction side of the blade roots.

Figure 3. SEM-image showing fatigue striations visible at high magnification. Arrows indicate crack propagation direction.
