LEAKAGE IN RADIATOR FITTINGS

Dezincification and stress corrosion cracking

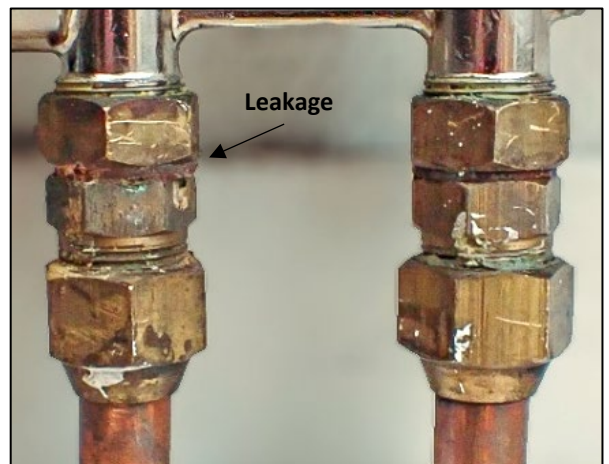
About 3 months after the replacement of a thermostatic radiator valve, a leakage suddenly occurred in one of the two fittings between the thermostat and the connected water pipes (Figure 1). During the valve replacement, the fittings had been loosened but not removed, and then reused. As there was no information of previous work done on the radiators, the fittings were assumed to be from the end of the 1960s, when the house was built.

Figure 1. Leaking vs non leaking fitting.

The leakage could probably have been prevented if fittings in dezincification-resistant brass had been installed during the thermostat change, instead of reusing the old fittings that were made of an alloy that is generally not resistant to corrosive mediums that might be used in the specific environment. Brass is particularly sensitive to ammonia, which is commonly found in some all-purpose cleaning agents.

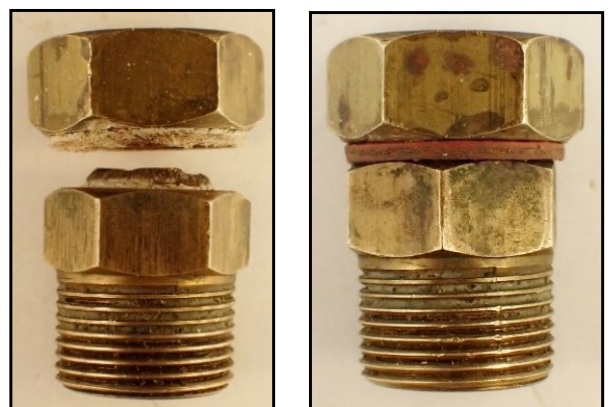
- The leakage had occurred due to cracking initiated at the sharp corner on the outer surface of the fitting (Figure 2).
- Investigation in SEM showed that the area adjacent to the fracture surface had suffered from dezincification (Figure 3). The same area in the non-leaking fitting had also suffered from dezincification and smaller cracks (100 µm) were observed (Figure 4). Dezincification is a corrosion process that selectively removes zinc from the brass alloy (if Zn>15%), leaving a porous copper-rich structure with reduced mechanical strength.
- The chemical composition of the fittings was identified as brass CW608N (60% Cu, 38% Zn, 2% Pb).
- The mode of fracture at the crack initiation sites was identified as ductile (Figure 5a). However, the majority of the fracture surface had an intergranular brittle mode of fracture (Figure 5b).

Figure 2. Leaking (fractured) fitting vs non-leaking fitting.
