LEAKING SEAWATER SYSTEM

Sigma phase embrittlement in pipe flanges

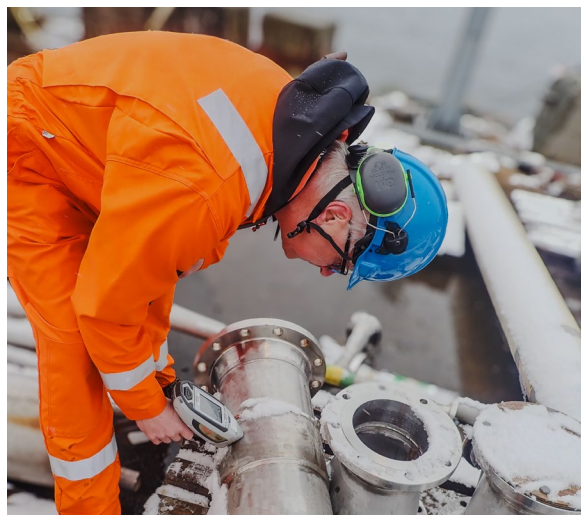
Figure 1. Chemical characterisation of pipe system on-site.

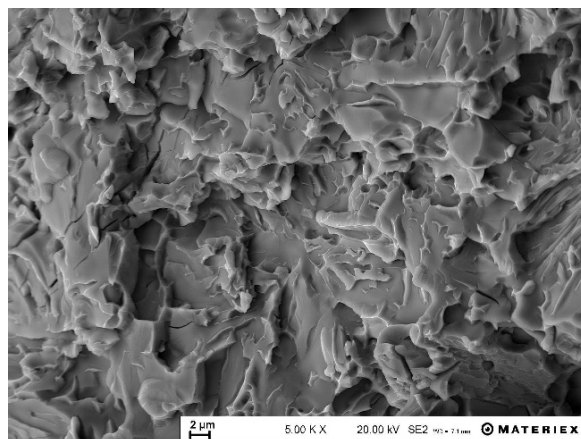
- Cracks and defects were observed in several flanges whereas the pipes and welds appeared to be in good condition.
- A detailed study using SEM showed that the cracked flange had the character of a typical brittle cleavage mode of fracture (Figure 2).
- EBSD phase mapping of the microstructure confirmed the presence of sigma phase in all investigated flange samples (Figure 3a). However, the pipes had an expected microstructure free from sigma phase and with a homogenous distribution of ferrite and austenite (Figure 3b).
- The hardness was higher than specified in areas rich in sigma phase (>10 wt.-%), as shown in Table 1. The pipe hardness was lower and did meet requirements according to the materials specifications.
- The chemical composition of all analysed pipes and flanges conformed with the specified super duplex stainless steel.

The flange material had suffered from what in the literature is known as Sigma phase embrittlement that had dramatically reduced the corrosion resistance and ductility of the flange material. Exposure to seawater had subsequently accelerated local corrosion and promoted cracking. Sigma phase is an undesired chromium/molybdenum-rich intermetallic phase that can form during incorrect heat treatment of stainless steel. Most likely, too slow cooling through the 700-900 °C temperature range after heat treatment has led to the eutectoid transformation of ferrite into sigma phase and secondary austenite.

Figure 2. Brittle cleavage mode of fracture, fractured flange.

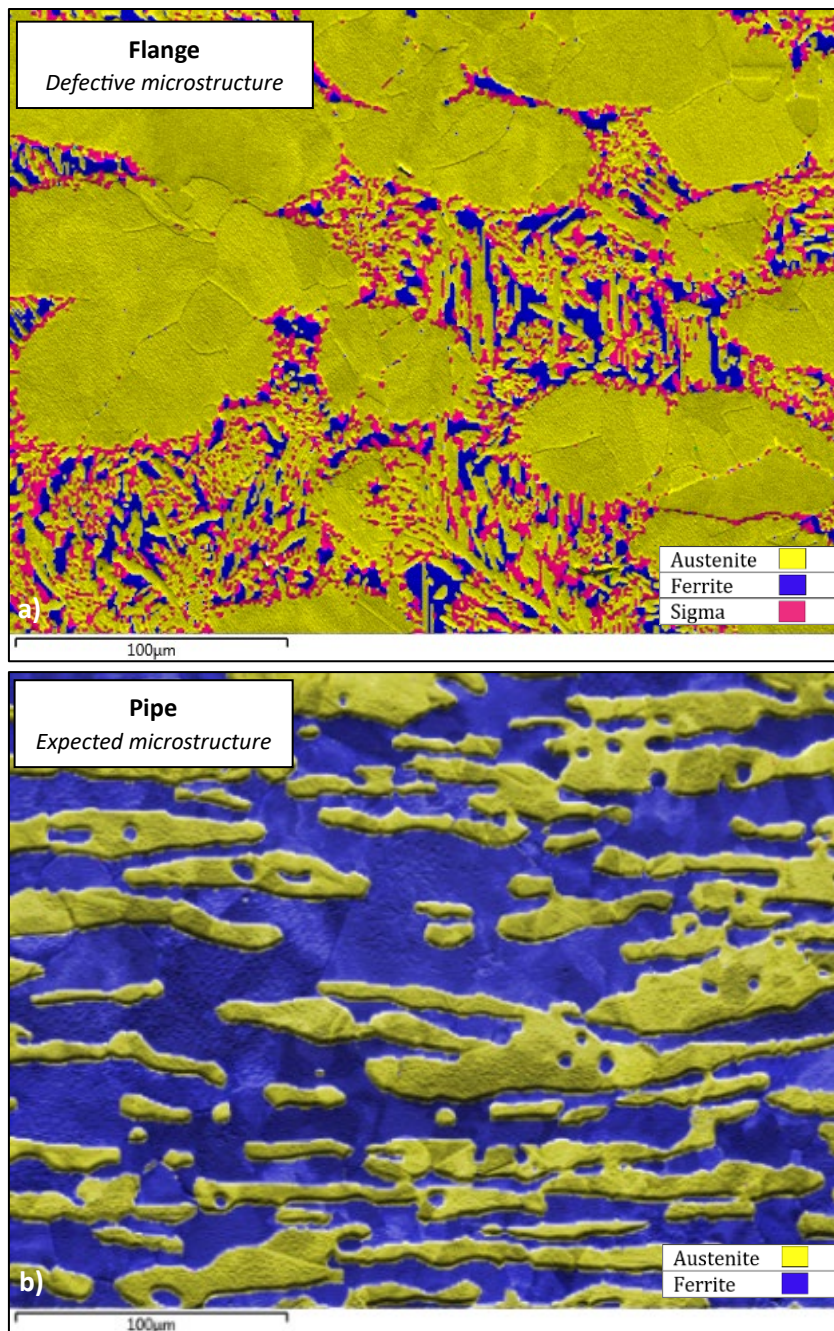
Figure 3. EBSD- phase mapping showing a) a defective microstructure with the presence of sigma phase, b) expected microstructure with a homogenous distribution of austenite and ferrite.
