## **MATERIEX CASE 24-1**

# HYDROGEN EMBRITTLEMENT IN STEEL FASTENER

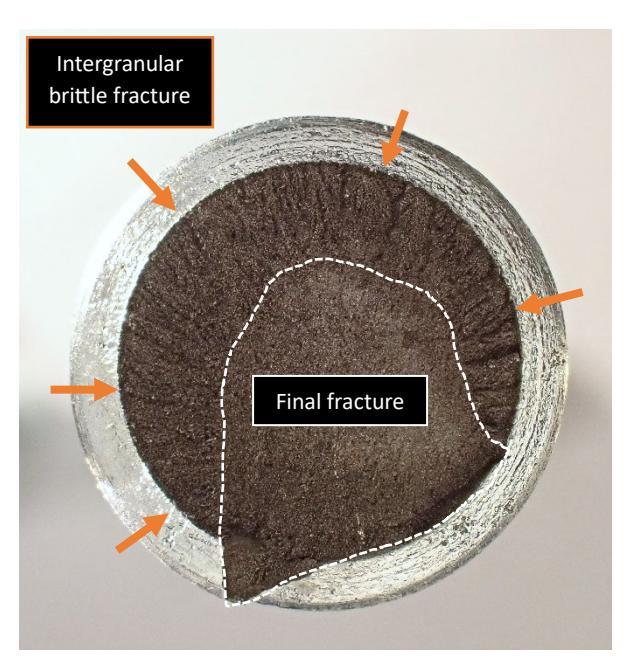
- The hardness was measured to 505 HV which meet the criteria for property class 45H.
- The macroscopic appearance of the fracture suggests that the fracture had been initiated in the thread root along the circumference (arrows in Figure 1) and rapidly propagated inwards/downwards towards the final fracture (white marked area in Figure 1).
- Investigation in SEM confirmed that the fracture had been initiated in the thread root. The fracture surface in this area had an intergranular brittle mode of fracture along the prior austenite grain boundaries (Figure 2). The grain facets exhibited so-called "crow's feet" (Figure 3) which is a microscopic feature typically associated with hydrogen embrittlement. The final fracture had a mixed ductile and brittle cleavage mode of fracture.

*Figure 1.* Fracture surface, arrows indicate crack initiation sites with an intergranular brittle mode of fracture. The white marked area shows the final fracture.

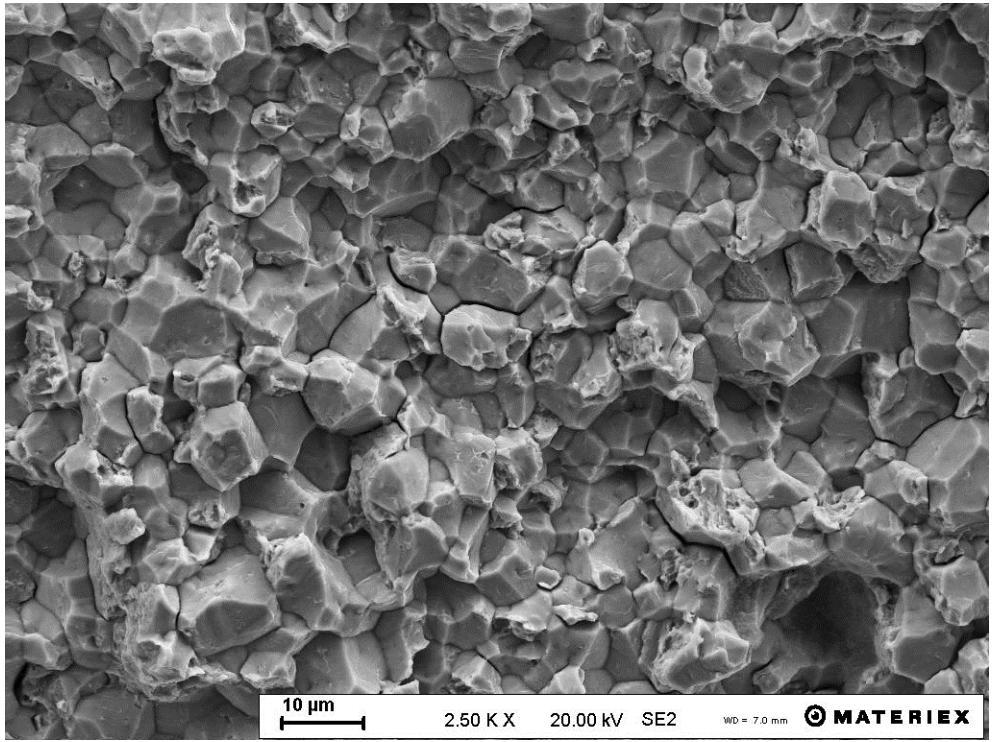
Figure 2. Intergranular brittle mode of fracture revealing austenite grain boundaries.

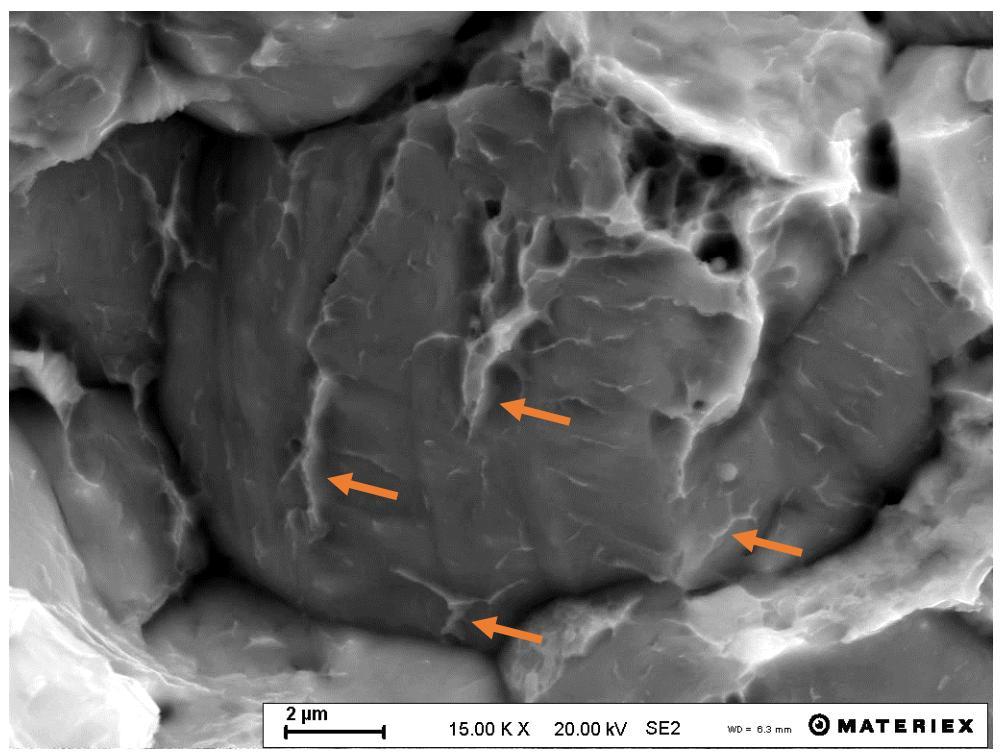
Figure 3. High magnification SEM- image showing the so-called crow's feet.
