MATERIEX CASE 24-4

STEAM TURBINE FAILURE

Fatigue induced blade ruptures

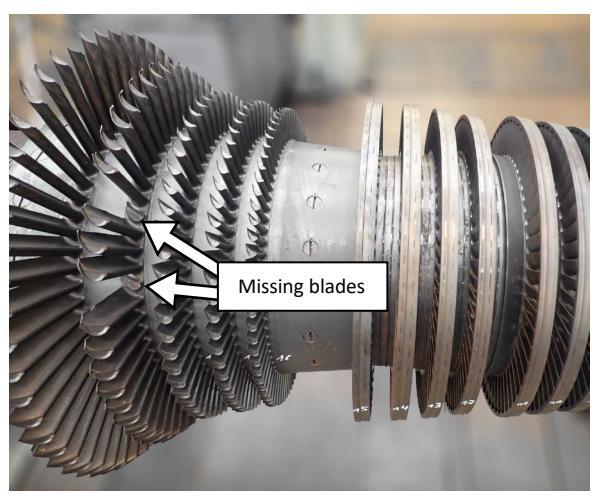
Two low pressure (LP) steam turbine rotor blade ruptures were discovered during an inspection that was carried out due to high vibrations during startups. The two ruptured blades had both been mounted in row 19, the 1st row in the LP stage. The blade material was specified to conform with EN 1.4923.

Figure 1. Two missing blades in LP-stage of steam turbine.

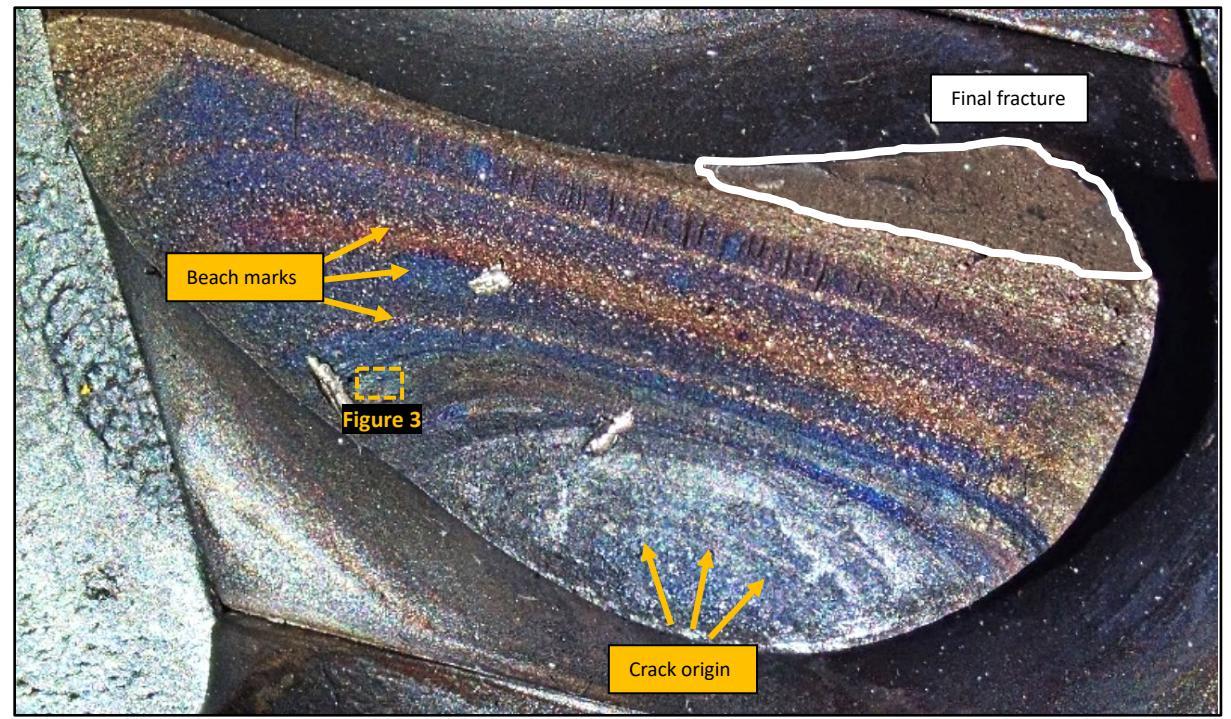
- Chemical composition and hardness measurements showed that the rotor blade material conformed with the specifications (Table 1-Table 2).
- The macroscopic appearance with beach marks visible on the fracture surfaces (Figure 2) indicated that the blade fractures had been caused by fatigue, initiated at the suction side of the blade roots. Beach marks are macroscopic concentric rings that represent sudden changes in load and/or environmental conditions.

- The total number of beach marks was estimated to be 30-50 which may be interpreted to equal the number of starts/stops needed to cause the fracture. The different colours of the beach marks indicate various degrees of oxidation which can be referred to different stages under which the fatigue crack has propagated.

Figure 2. Fracture surface of the blade root, shows a large number of beach marks indicating that the fracture has been caused by fatigue.

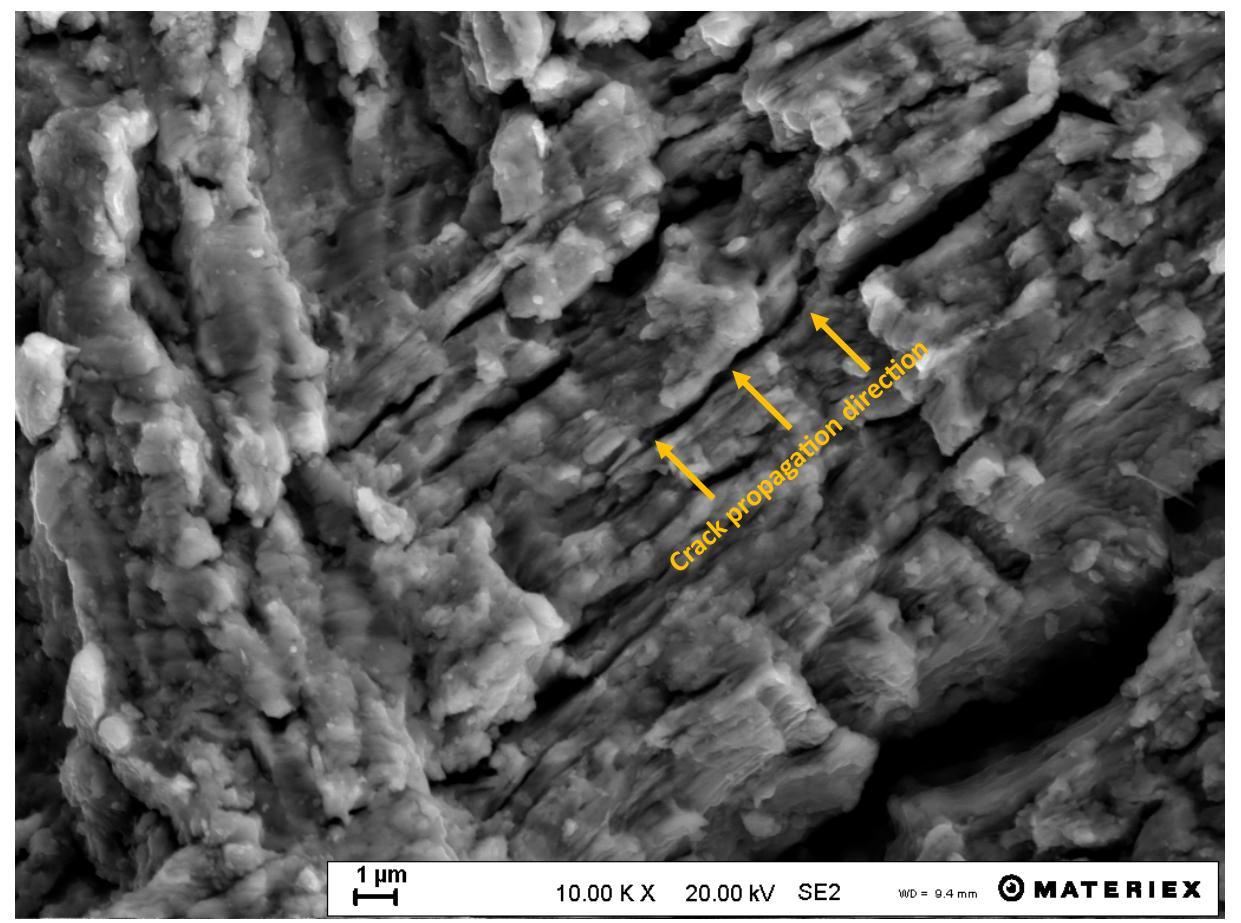
- A detailed study of the fracture surface in SEM showed the presence of so-called striations (Figure 3). Striations are microscopic parallel lines associated with fatigue failures where each line represents the crack front during one load cycle. The shape of the striations further confirmed that the fractures had been initiated at the suction side of the bade roots.

Figure 3. SEM-image showing fatigue striations visible at high magnification. Arrows indicate crack propagation direction.
