MATERIEX CASE 24-4

STEAM TURBINE FAILURE

Fatigue induced blade ruptures

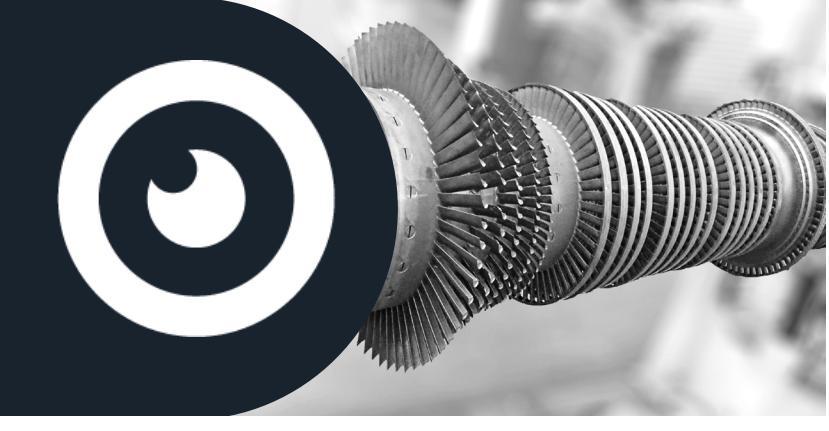
Two low pressure (LP) steam turbine rotor blade ruptures were discovered during an inspection that was carried out due to high vibrations during startups. The two ruptured blades had both been mounted in row 19, the 1st row in the LP stage. The blade material was specified to conform with EN 1.4923.

Figure 1. Two missing blades in LP-stage of steam turbine.
